RURAL ENERGY PROGRAM

ENVIRONMENTAL MANAGEMENT PLAN FOR MACHAKHELA SMALL HYDROPOWER REHABILITATION PROJECT

Prepared for: USAID / Caucasus
25 Atoneli Street
0105 Tbilisi, Georgia

Prepared by: Rural Energy Program 26 Dzmebi Kakabadzebi Street, Tbilisi,
0105, Georgia
Tel: +995 32 50 63 43
Fax: +995 32 93 53 52

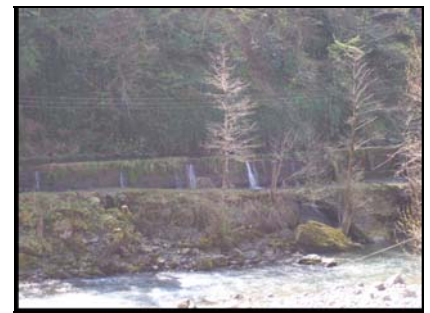
Canal

Machakhea SHP diversion canal requires significant repair works. Pressure basin and sluice is located at the end of 2,163 m long diversion canal. The right wall of the canal between the first and second spillway is supported on the outside with buttresses. In some sections of the canal, the buttresses are missing and the canal walls are in danger of collapsing. Run of the water from the hill above the canal has damaged large sections of the canal. As a result there is significant leakage from the canal.

Three vehicle passages are constructed on the derivation canal; currently they are in poor condition and require rehabilitation. The work at the canal includes following activities:
